TECH TIP

MC521 Controller Firmware Revision M

Tech Tip: TT070917

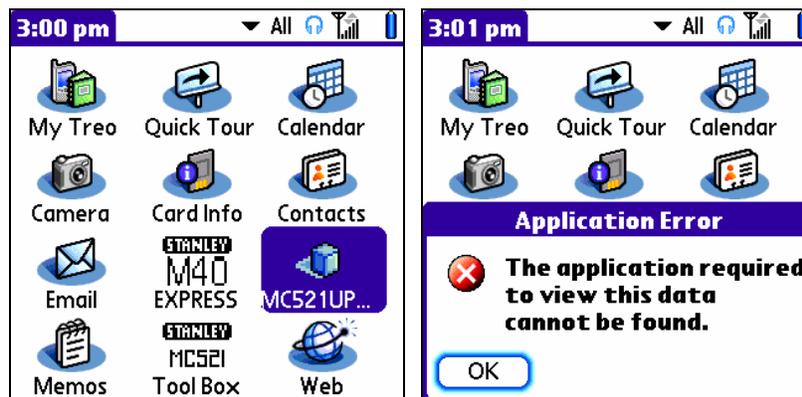
*Note: The firmware will show on the Palm screen as an icon labeled 'MC521UP...' which is not an executable program and will display an error message if tapped (see below).

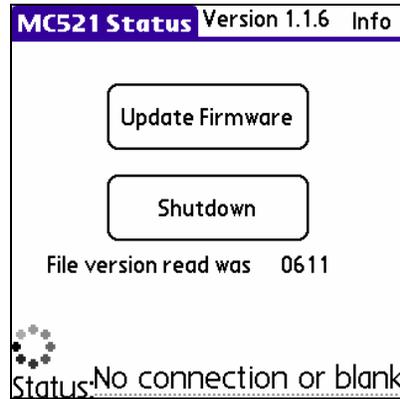
With the cable not connected to the Palm device tap on the 'MC521 Tool Box' icon.

The following screen will be displayed:

Version 1.1.6 at the top of the screen is the latest Palm software (Rev. H) and version 0611 below the Shutdown button is the latest firmware (Rev. M) on the card.

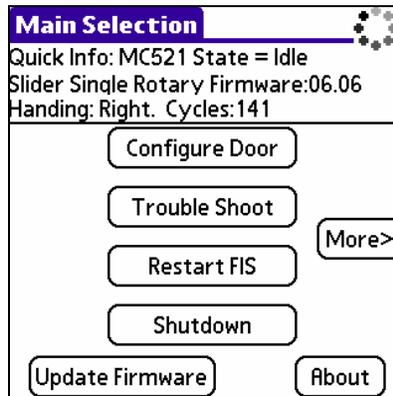
On the Palm screen tap on the 'MC521 Tool Box' icon.

The following screen will be displayed (note the firmware shown on this screen will indicate which version is currently installed on the MC521 controller):

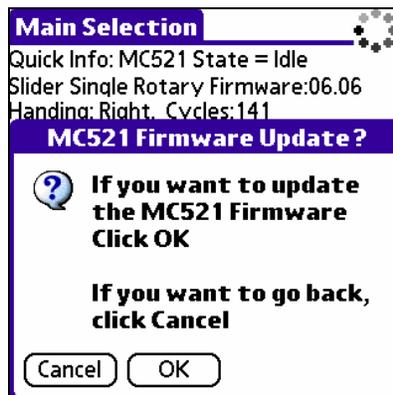
Tap on the 'Update Firmware' button.

The following screen will be displayed:

Tap on the 'OK' button.
